April 6, 2023

Mold Investigation Report: Findings of Initial Assessment

**Grant Elementary School
Classrooms 70-75
2368 Pearl Street
Santa Monica, CA 90405**

FACS Project #PJ75644

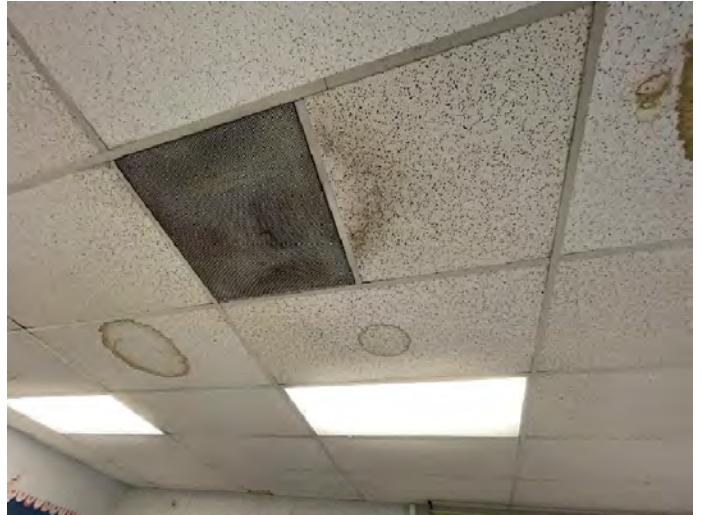
#1: Classroom 70	<p>History: Report of roof leaks by Grant Elementary School staff. No major repairs or renovations have occurred.</p> <p>Observations: Water stained drop ceiling tiles throughout the room. No observable stains on carpet or walls. Dark staining observed on wood behind ceiling insulation. No elevated moisture meter readings. No observable odor in room. No visible mold growth was observed.</p> <p>Conclusion: Although visible mold growth was not identified, there is potential for mold growth based on observable water staining on ceiling tiles and air sample results which were slightly elevated compared to outdoor control samples, indicating potential hidden mold growth.</p> <p>Cause: Suspected to be reported ceiling leak.</p>	<p><u>Photos</u> 1 – 5</p> <p><u>Samples</u> F150180: IA1</p>	Not elevated	Potential	<p>MT Level</p> <ul style="list-style-type: none"> • Repair cause of roof leaks • Refer to “MT Level” procedures in the attached “General Mold Remediation Guidelines” • Remove all water stained ceiling tiles and stained insulation in ceiling. In the course of removal, proceed in a manner that minimizes disturbance of potential concealed mold growth. • Inspect underlying building materials for mold growth in the ceiling. If mold growth is discovered, remediate in accordance with “General Mold Remediation Guidelines” (e.g. PPE, containment provisions, work practices, etc.) • Wet wipe exposed horizontal surfaces and run HEPA air cleaners (with HVAC fan on) for at least 24 hours. • Conduct post-remediation sampling.

Photo #2: Classroom 70 – water staining on ceiling tiles throughout

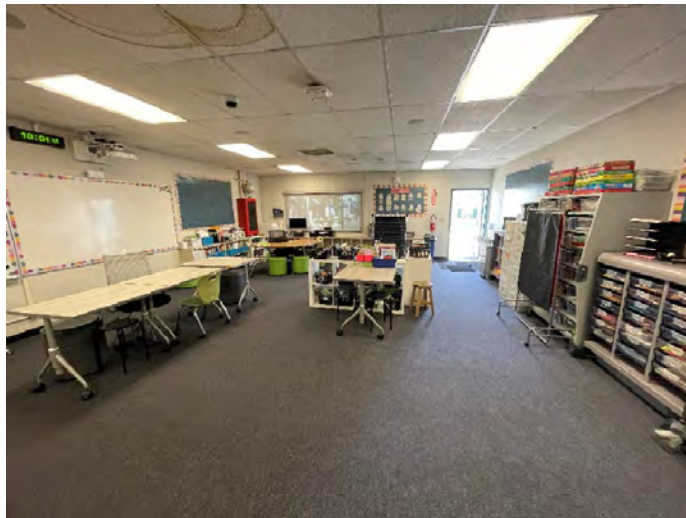
Photo #3: Classroom 70 – water staining on ceiling tile throughout

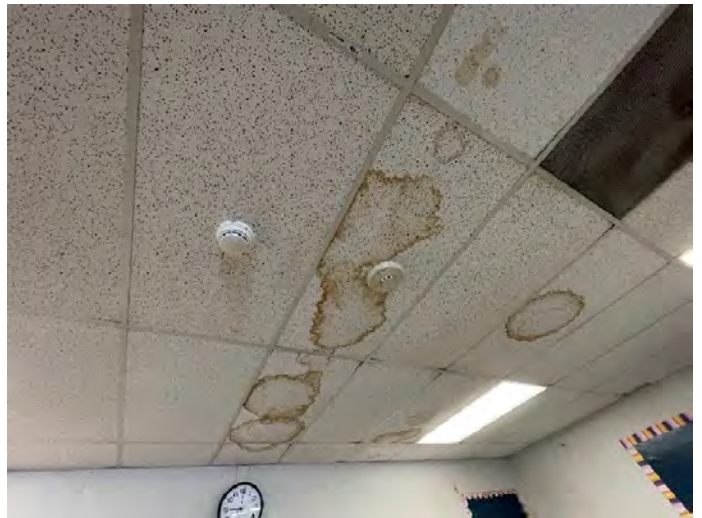
Photo #4: Classroom 70 – water staining on ceiling tile throughout

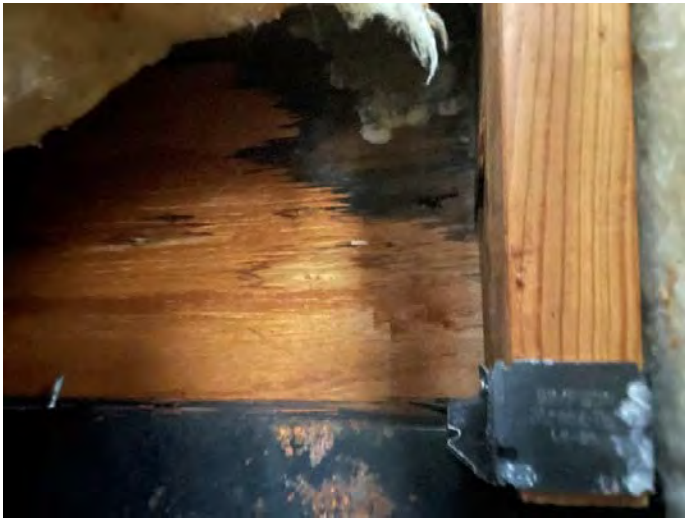
Photo #5: Classroom 70 black staining on wood in ceiling cavity

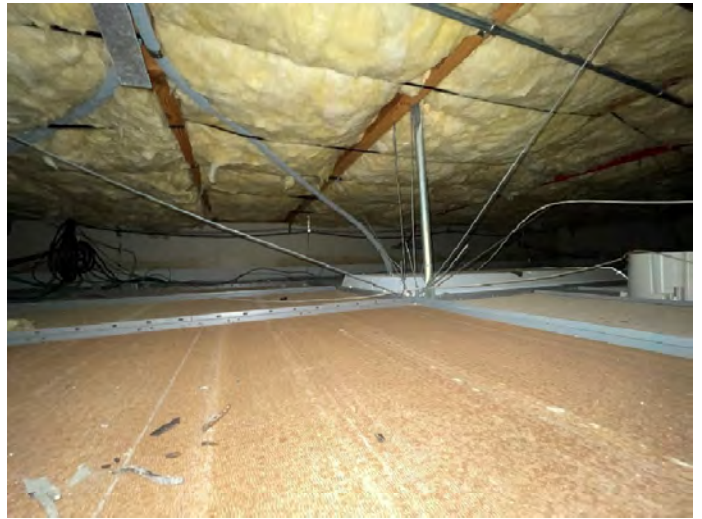
#2: Classroom 71	<p>History: Report of roof leaks by Grant Elementary School staff. No major repairs or renovations have occurred.</p> <p>Observations: Minor debris observed above the drop ceiling tiles. No observable stains on ceiling, carpet, or walls. No elevated moisture meter readings. No observable odor in room. No visible mold growth observed. Upon inspection, air handling unit appeared dirty and due for general cleaning/maintenance (heavy dust accumulation).</p> <p>Conclusion: Mold growth is not suspected. Elevated mold spore levels in air and on surfaces are not suspected. This is based on the absence of visible mold growth and air sample results indicating levels similar to outdoors.</p> <p>Cause: N/A</p>	<p><u>Photos</u> 6 – 8</p> <p><u>Samples</u> F150180: IA3</p>	Not elevated	Not Suspected	<ul style="list-style-type: none"> Perform general cleaning/maintenance of Classroom 71 air handling unit (AHU), including replacing filter, cleaning evaporative coils, drain pan, and other accessible components

Photo #8: Classroom 71 – light debris in ceiling cavity

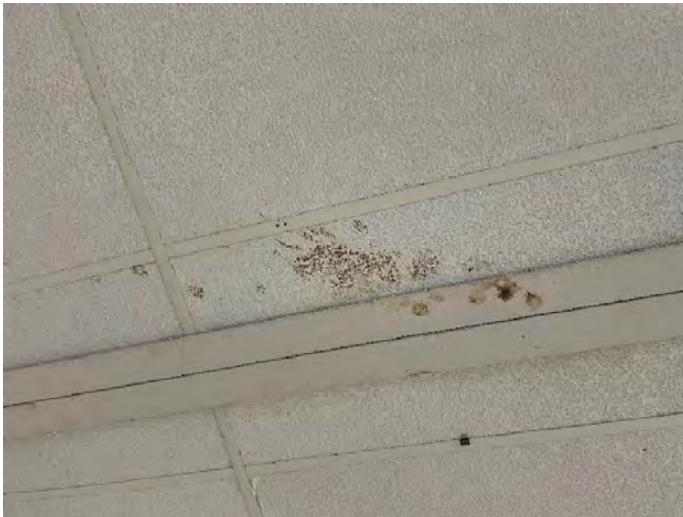
#3: Classroom 72	<p>History: Report of roof leaks by Grant Elementary School staff. No major repairs or renovations have occurred.</p> <p>Observations: No observable stains on ceiling, carpet, or walls. No elevated moisture meter readings. No observable odor in room. No visible mold growth observed.</p> <p>Conclusion: Mold growth is not suspected. Elevated mold spore levels in air and on surfaces are not suspected. This is based on the absence of visible mold growth and air sample results indicating levels similar to outdoors.</p> <p>Cause: N/A</p>	<p><u>Photos</u> 9 – 11</p> <p><u>Samples</u> F150180: IA5</p>	Not elevated	Not Suspected	N/A

Photo #11: Classroom 72 – light ceiling staining observed

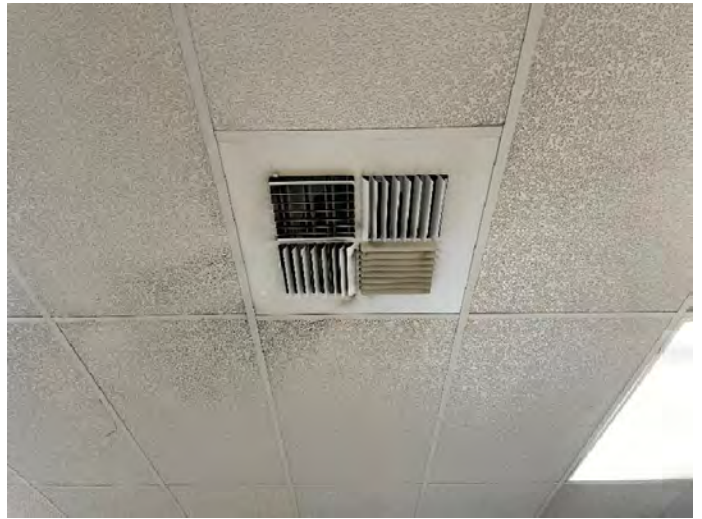
#4: Classroom 73	<p>History: Report of roof leaks by Grant Elementary School staff. No major repairs or renovations have occurred.</p> <p>Observations: Staining on ceiling tiles surrounding HVAC supply registers. Rust observed on top of registers. No observable stains on carpet or walls. No elevated moisture meter readings. No observable odor in room. No visible mold growth observed.</p> <p>Conclusion: Mold growth is not suspected. Elevated mold spore levels in air and on surfaces are not suspected. This is based on the absence of visible mold growth and air sample results indicating levels similar to outdoors.</p> <p>Cause: N/A</p>	<p><u>Photos</u> 12 – 16</p> <p><u>Samples</u> F150180: IA7</p>	Not elevated	Not Suspected	N/A

Photo #14: Classroom 73 – ceiling staining observed near HVAC supply registers

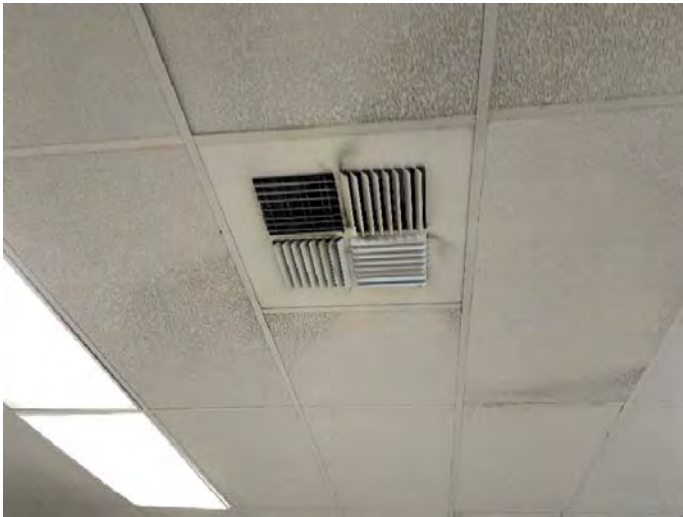
Photo #15: Classroom 73 – ceiling staining observed near HVAC supply registers

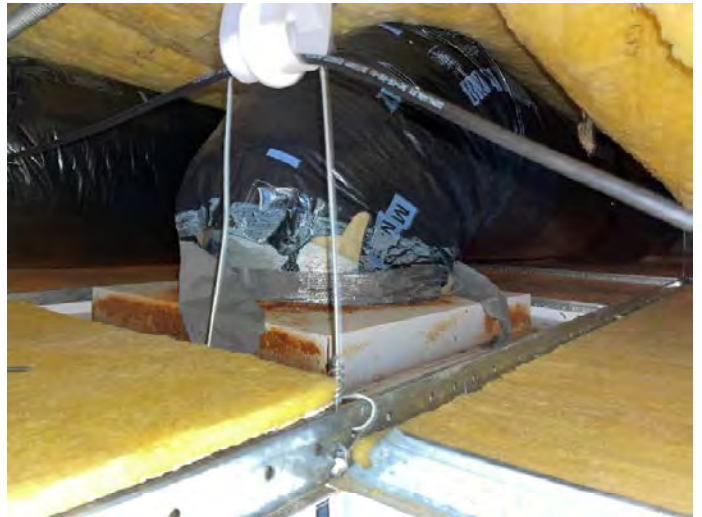
Photo #16: Classroom 73 - rusted HVAC supply

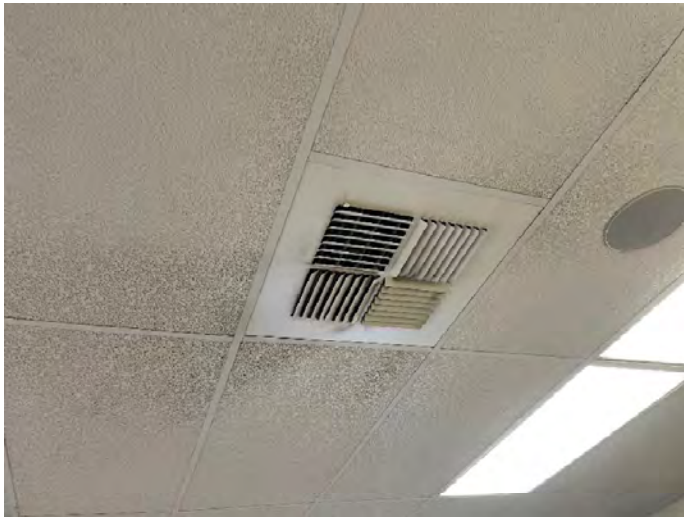
#5: Classroom 74	<p>History: Report of roof leaks by Grant Elementary School staff. No major repairs or renovations have occurred.</p> <p>Observations: Staining on ceiling tiles surrounding HVAC supply registers. Rust observed on top of registers. No observable stains on carpet or walls. No elevated moisture meter readings. No observable odor in room. No visible mold growth observed.</p> <p>Conclusion: Mold growth is not suspected. Elevated mold spore levels in air and on surfaces are not suspected. This is based on the absence of visible mold growth and air sample results indicating levels similar to outdoors.</p> <p>Cause: N/A</p>	<p><u>Photos</u> 17 – 21</p> <p><u>Samples</u> F150180: IA9</p>	Not elevated	Not Suspected	N/A

Photo #19: Classroom 74 – ceiling staining observed near HVAC supply registers

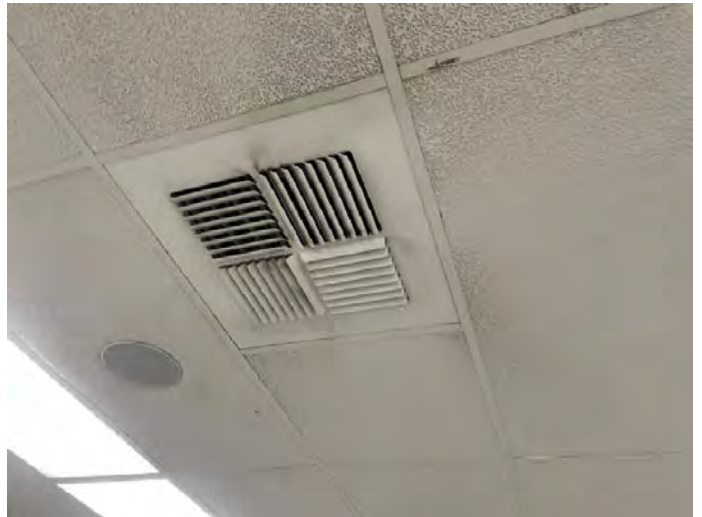
Photo #20: Classroom 74 – ceiling staining observed near HVAC supply registers

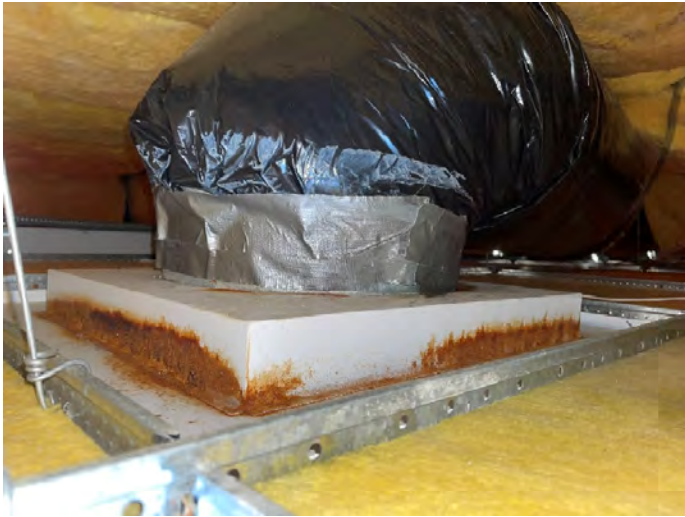
Photo #21: Classroom 74 - rusted HVAC supply

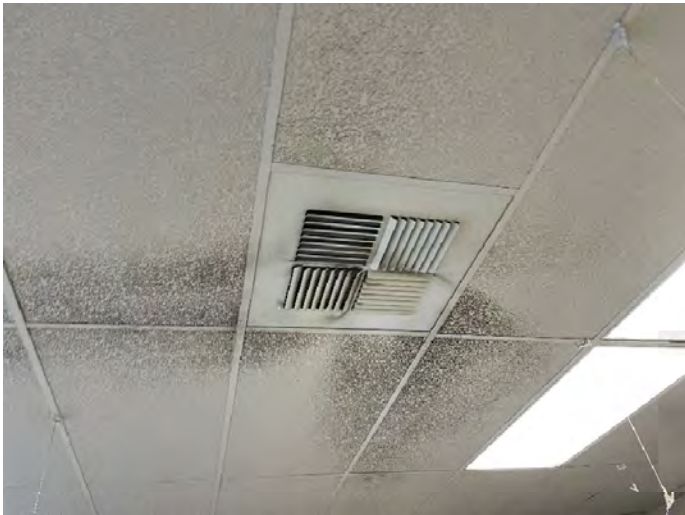
#6: Classroom 75	<p>History: Report of roof leaks by Grant Elementary School staff. No major repairs or renovations have occurred.</p> <p>Observations: Heavy staining on ceiling tiles surrounding HVAC supply registers. Rust observed on top of registers. No observable stains on carpet or walls. No elevated moisture meter readings. No observable odor in room. No visible mold growth observed.</p> <p>Conclusion: Mold growth is not suspected. Elevated mold spore levels in air and on surfaces are not suspected. This is based on the absence of visible mold growth and air sample results indicating levels similar to outdoors.</p> <p>Cause: N/A</p>	<p><u>Photos</u> 22 – 25</p> <p><u>Samples</u> F150180: IA11</p>	Not elevated	Not Suspected	N/A

Photo #23: Classroom 75 – ceiling staining observed near HVAC supply registers

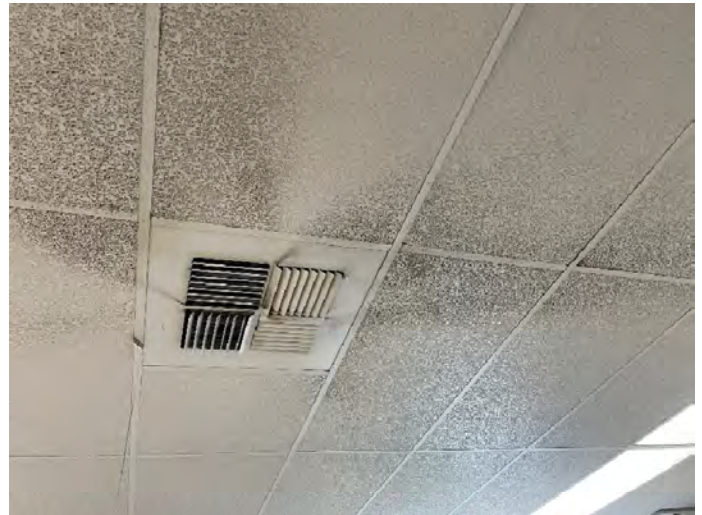
Photo #24: Classroom 75 – ceiling staining observed near HVAC supply registers

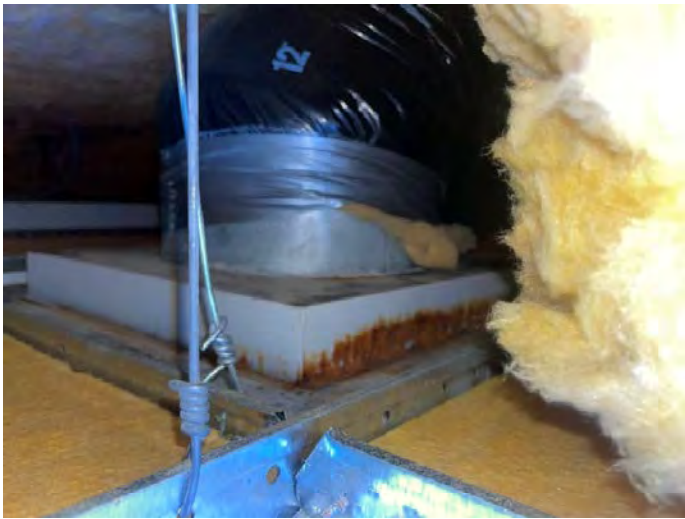
Photo #25: Classroom 75 - rusted HVAC supply

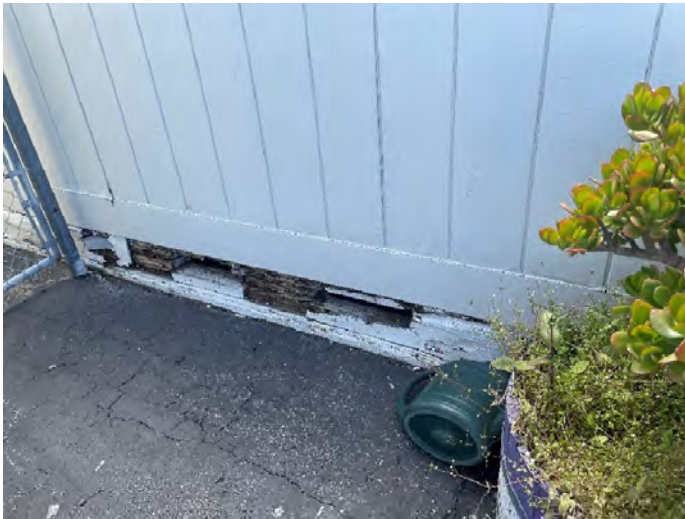
#7: Exterior of Classrooms 70 thru 75	<p>Observations: Light to moderate vegetation surrounding the bungalow classrooms. Wood siding, which was observed to have wood rot at base. Classroom 71 HVAC unit observed to have rust and heavy dust deposition. All other classroom HVAC units appeared in acceptable condition.</p>	<p><u>Photos</u> 26 – 32</p> <p><u>Samples</u> F150180: OA1, OA2</p>	N/A	Not Suspected	<ul style="list-style-type: none"> • Perform general cleaning/maintenance of Classroom 71 air handling unit (AHU) • Repair areas of deteriorated wood siding

Photo #27: Wood rot observed at the exterior of the bungalows

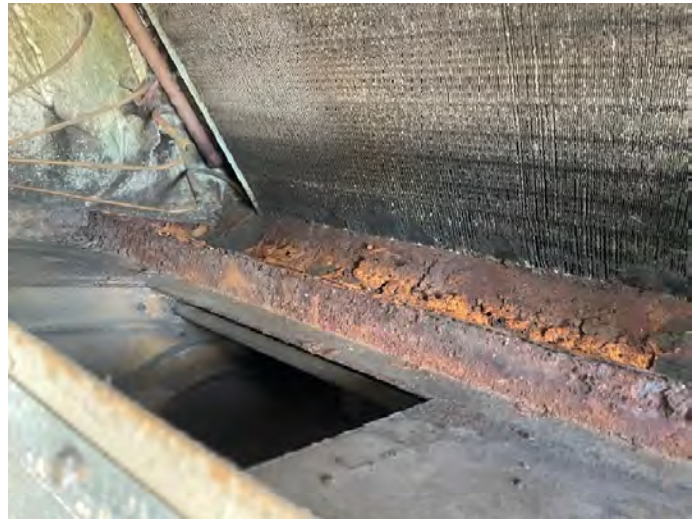
Photo #28: Classroom 71 air handling unit, heavy dust deposition and rusting observed

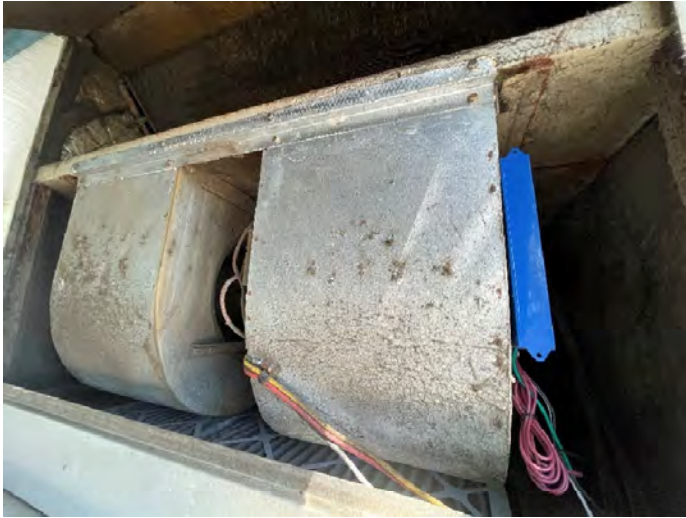
Photo #29: Classroom 71 air handling unit, heavy dust deposition and rusting observed
