CLIENT:SMMUSDPROJECT NO:SMSD-20-9871PROJECT:Santa Monica High School PCB surveyDate:11/16/2020

History Building

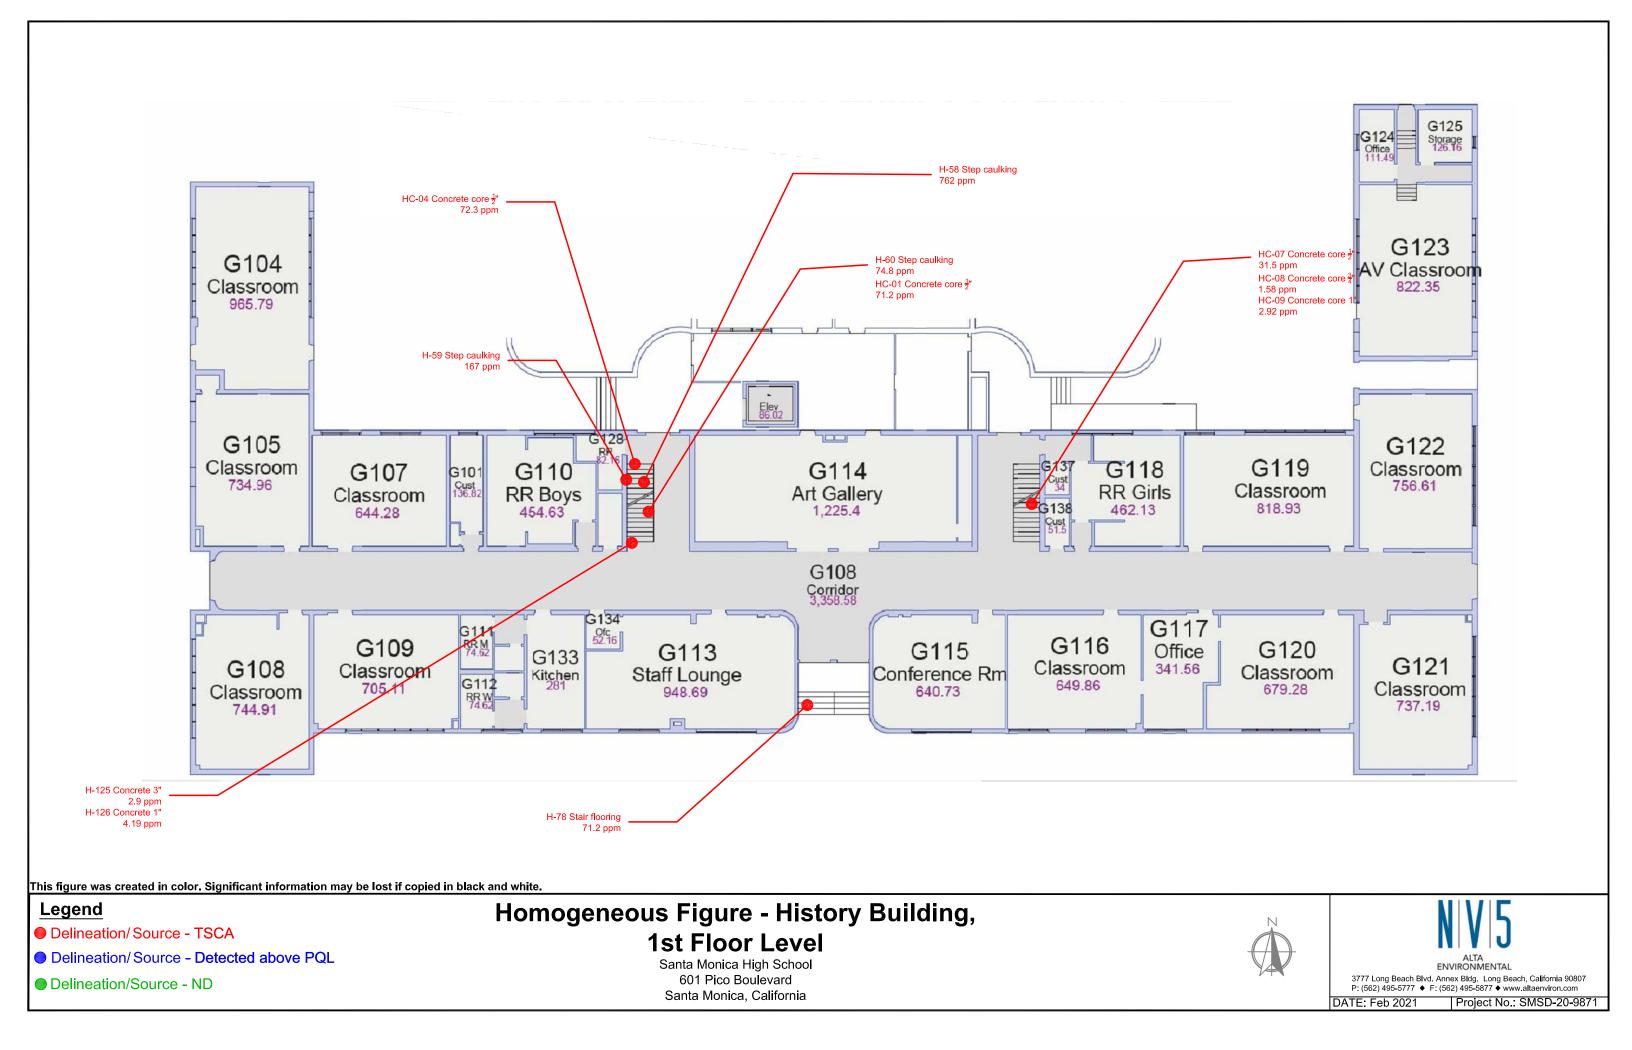
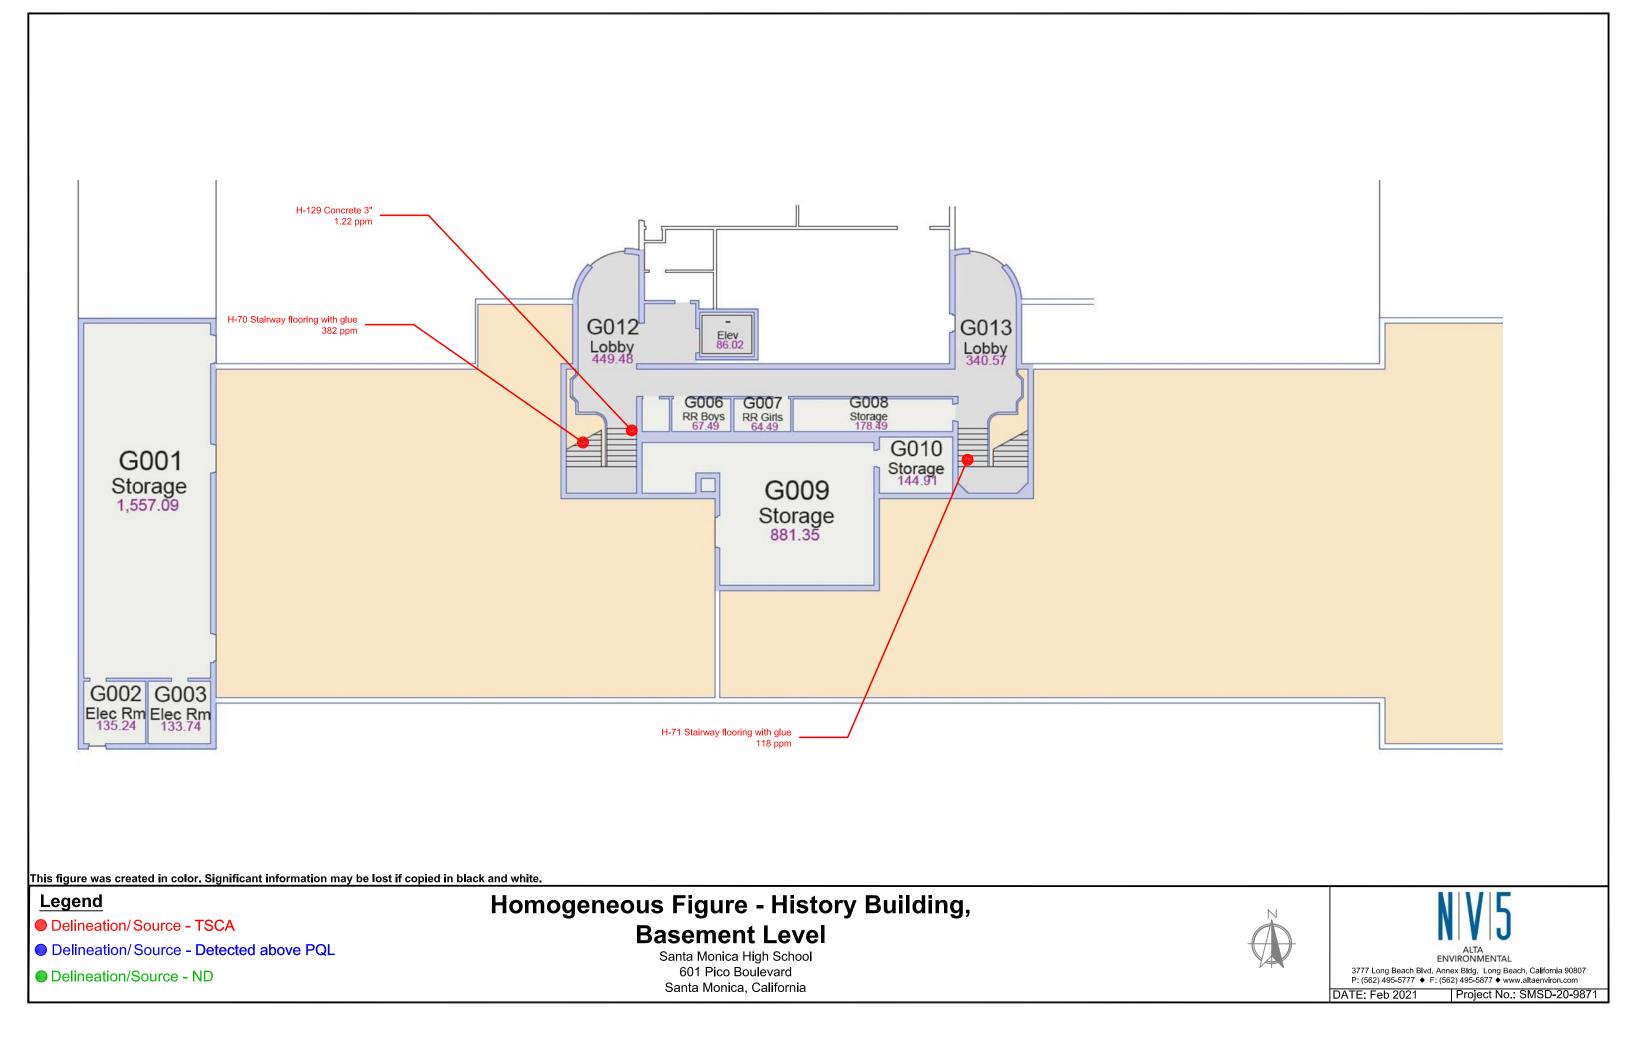
Sample Number	Sample Description	Sample Location	Material Location	Total PCBs (ppm)
H-58	Step caulking	Middle step	Northwest interior basement stairway to 1st floor	762
H-59	Step caulking	Bottom step	Northwest interior basement stairway to 1st floor	167
H-60	Step caulking	Top step	Northwest interior basement stairway to 1st floor	74.8
H-70	Stairway flooring with glue	1st floor	Northwest stairway	382
H-71	Stairway flooring with glue	1st floor	Northeast stairway	118
H-78	Stair flooring	Top step near south entrance	Exterior entrance stairs non-skid flooring	71.2
H-125	Concrete 3"	Northwest stairway base to 1st floor	Northwest interior basement stairway to 1st floor	2.9
H-126	Concrete 1"	Northwest stairway base to 1st floor	Northwest interior basement stairway to 1st floor	4.19
H-129	Concrete 3"	Northwest interior basement stairway to 1st floor, top step	Northwest interior basement stairway to 1st floor	1.22

HC-01	Concrete core 1/2"	Stairs to 1st floor	Northwest stairwell	71.2
HC-04	Concrete core 1/2"	Stairs to 1st floor	Northwest stairwell	72.3
HC-07	Concrete core 1/2"	Northeast stairwell	Northeast stairwell	31.5
HC-08	Concrete core 3/4"	Northeast stairwell	Northeast stairwell	1.58
HC-09	Concrete core 1"	Northeast stairwell	Northeast stairwell	2.92

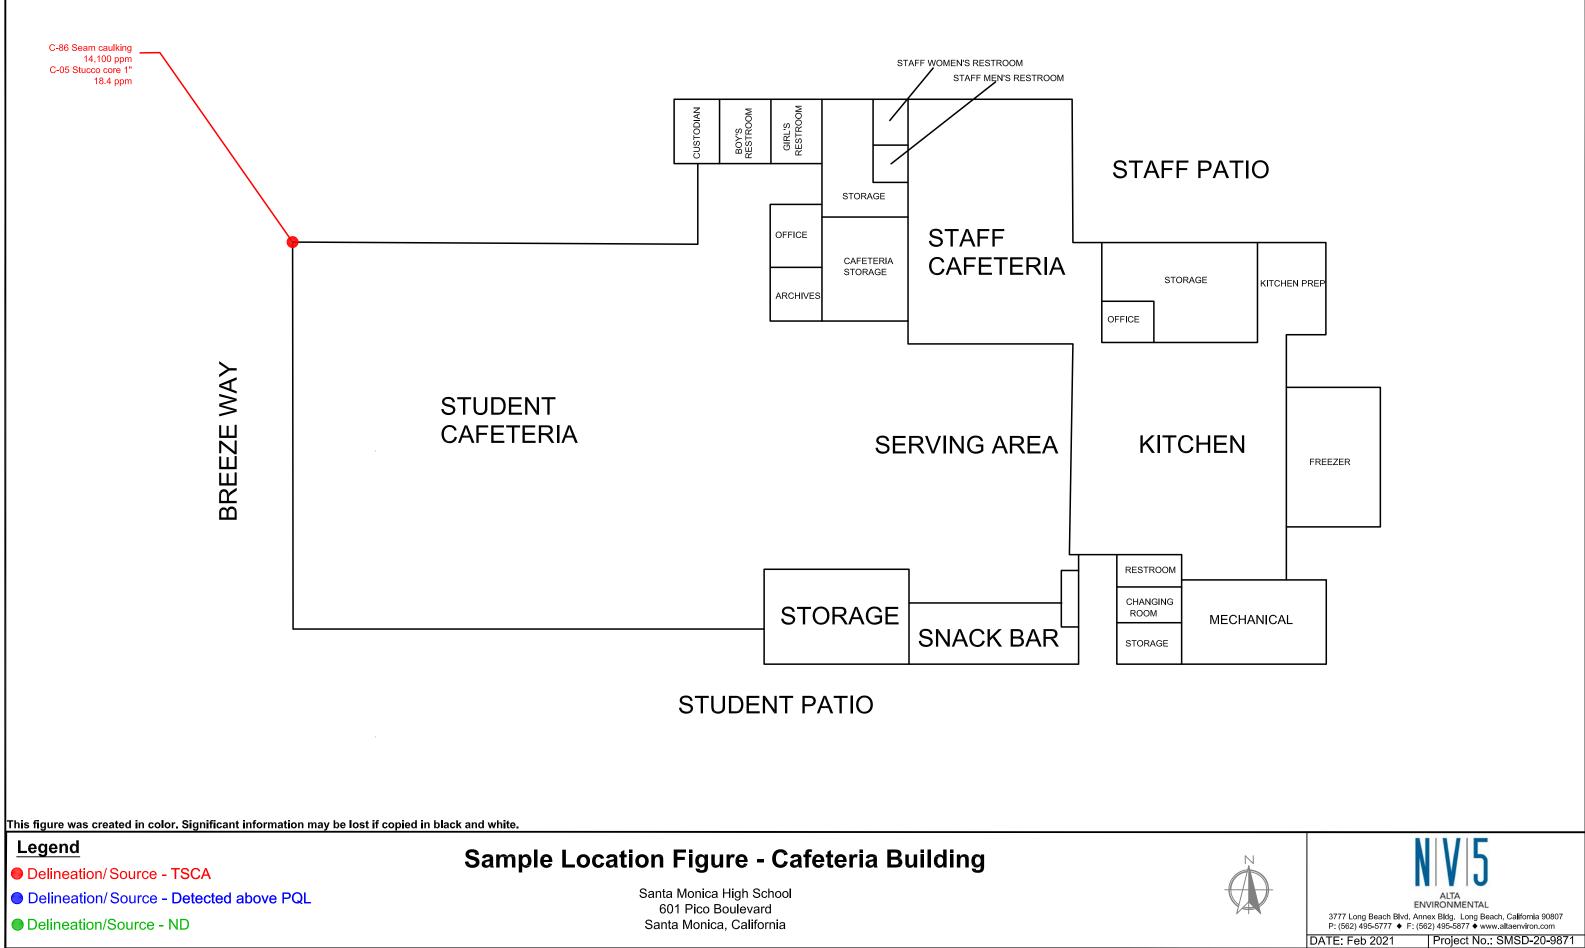
Cafeteria Building

Sample Number	Sample Description	Sample Location	Material Location	Total PCBs (ppm)
C-86	Seam caulking	Northwest corner	Exterior wall seam between concrete and stucco	14100
C-05	Stucco core 1"	Exterior northwest corner	Exterior wall seam between concrete and stucco	18.4

Note: No exterior door caulking observed.
