RE **Wildfire Smoke Impact Assessment – Webster Elementary School (FACS# PJ84910)**

Forensic Analytical Consulting Services, Inc. (FACS) was retained by ASCIP on behalf of Santa Monica-Malibu Unified School District (SMMUSD) to provide remediation recommendations following wildfire smoke impact caused by the Franklin Fire that erupted in Malibu on December 9, 2024, and reached properties directly adjacent to the Webster Elementary School campus located at 3602 Winter Canyon Road in Malibu, California.

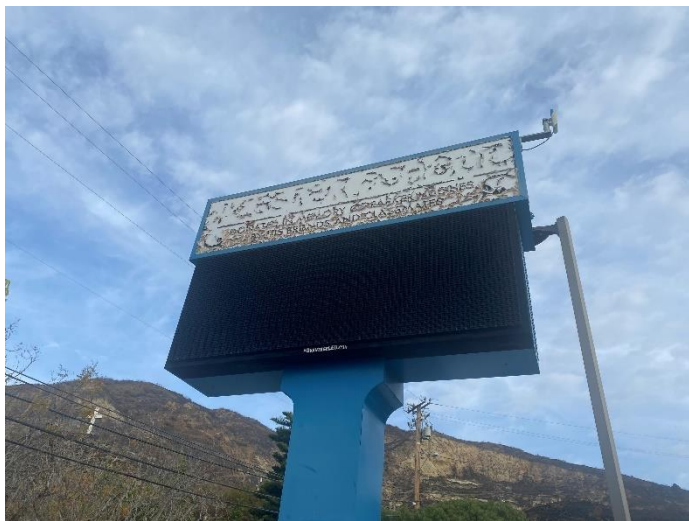
- Heavy smoke odor was present.
- The fire did not reach the school campus but was within 500 ft of the campus. Burned vegetation was identified on the hillside adjacent to the campus.
- Visible smoke debris was identified throughout the campus's exterior grounds.
- Visible fire and heat damage (peeling paint) was identified on the school sign.

Photo #1: Heat damage of school sign

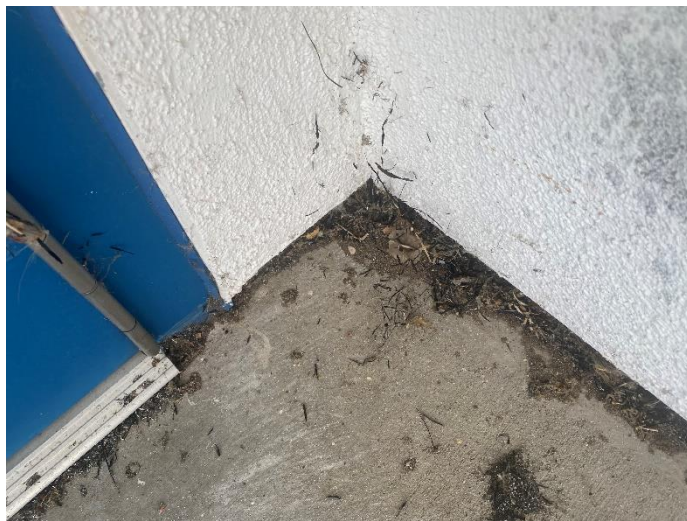
Photo #2: Smoke and fire debris identified on exterior surfaces

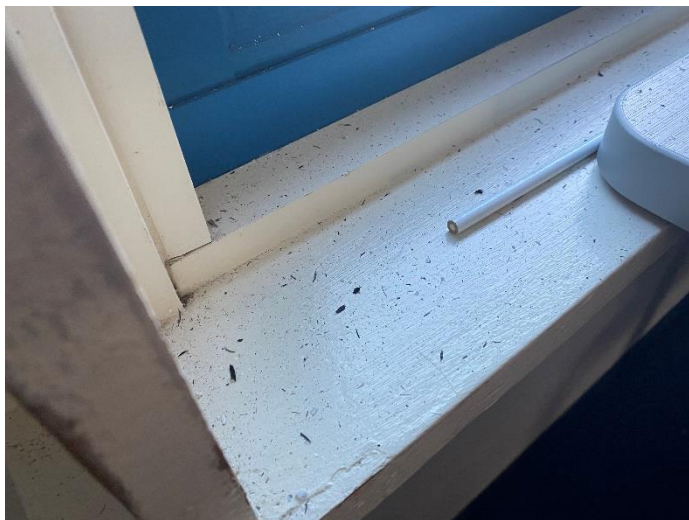
- Visible smoke related particulate (i.e., char and ash) was observed on surfaces located directly adjacent to exterior entry points (window and exterior doors; within 5 ft radius) in the majority of rooms assessed.

Photo #3: Bldg A, Classroom 17 - visible smoke related particulate on interior window surfaces

- c. Interior Surfaces:
 - i. Interior Window Surfaces: Non-porous surfaces (i.e., window blinds, framing and windowsills), may be washed with a detergent-water mix as appropriate.

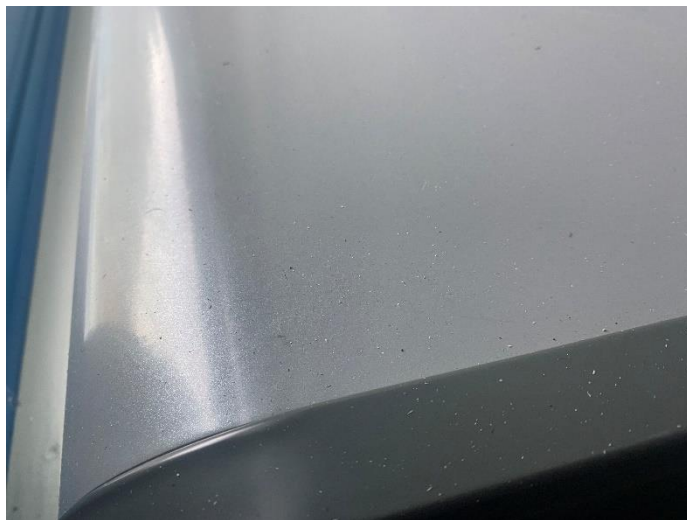
Photo #4: Bldg H, Classroom 4 – visible smoke related particulate on surfaces located directly adjacent to exterior entry points (<5 ft.)

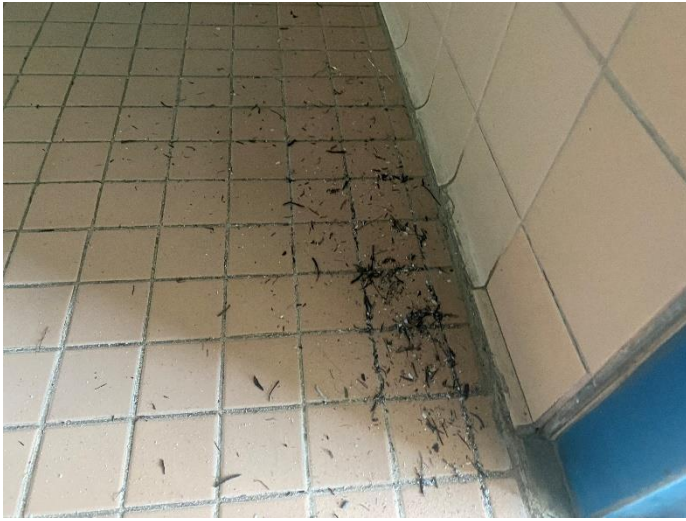
- In locations with visible exterior openings (e.g., bathroom outdoor air vent), the impact of wildfire smoke was more apparent and extended further than 5 feet.

Photo #5: Bldg H, Restroom – Heavy fire smoke debris on flooring throughout room

- ii. Walls and Ceilings: Surfaces may be washed with a detergent-water mix as appropriate.
 - iii. Flooring: All flooring materials can be HEPA vacuumed and or wet-wiped with a detergent-water mix as appropriate. If odors persist following initial cleaning efforts, removal and replacement of flooring may be necessary.

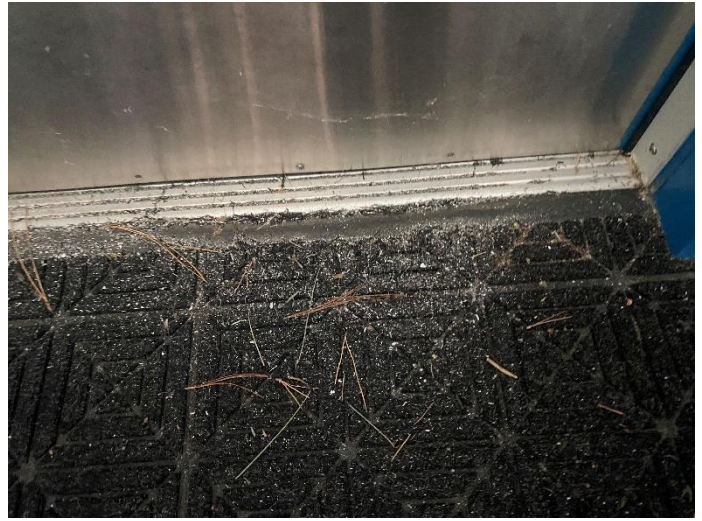
Photo #6: Bldg C, Classroom 13 – visible smoke related particulate on flooring at door entry

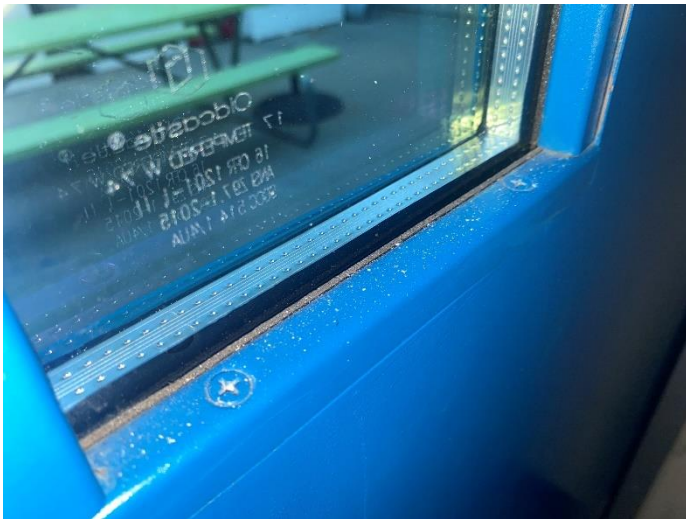
Photo #7: Bldg F, Classroom 2 - visible smoke related particulate on interior door

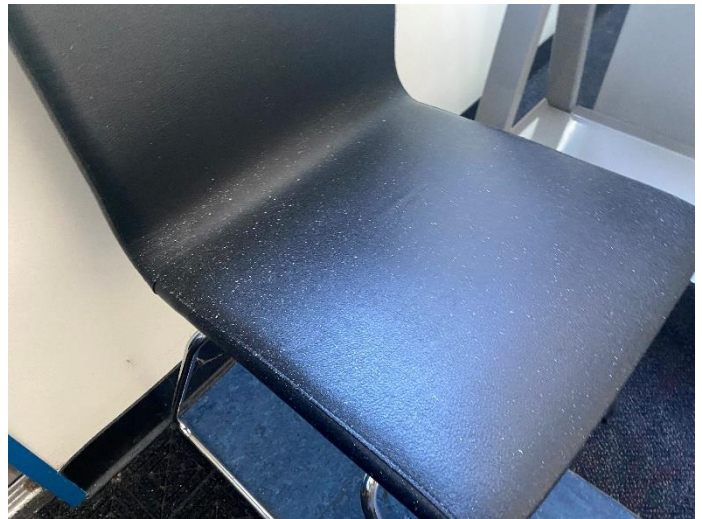
Photo #8: Bldg C, Classroom 14 - visible smoke related particulate on contents located directly adjacent to exterior entry points (<5 ft.)
