# Wildfire Smoke Impact Assessment: Findings of Site Investigation

**Webster Elementary School  
3602 Winter Canyon Road  
Malibu, CA 90265**

**FACS Project # PJ88022**

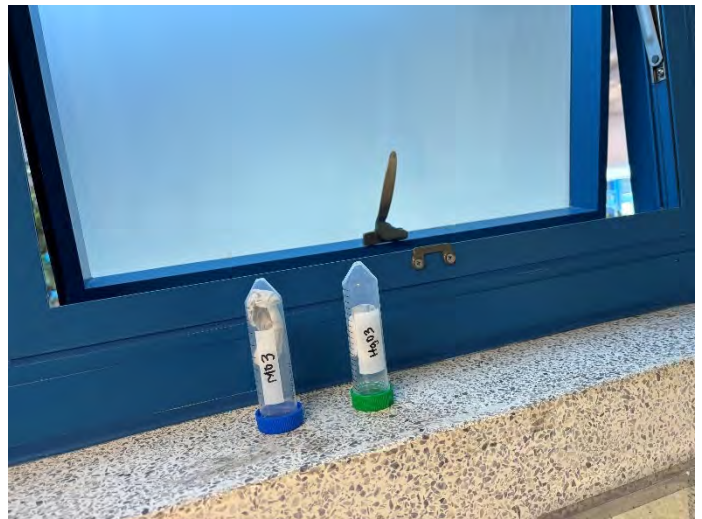
Photo #7: Building C – Girls Restroom – Windowsill –  
T-02

- No observable smoke odor was present, except in Room 13 and 16A where potential smoke odor was noted.
- Interior surfaces appeared visibly clean. No visible signs of smoke impact (e.g., smoke-related particulate, staining) were observed, with the exception of a minor amount of smoke related particulate observed on the Girls Restroom window sill.

1. In general, surfaces appeared visibly clean. No visible signs of smoke impact (e.g., smoke-related particulate, staining) were observed, with the exception of a minor amount of smoke related particulate observed on several window sills upon close inspection. Likewise, sampling of settled dust found smoke particulates above background levels at several entry point locations (windows and door thresholds). Additional and more frequent routine cleaning focusing on these areas is recommended. Flooring and window surfaces should be HEPA-vacuumed and/or wet-wiped with a cleaner/detergent mix as appropriate.
