LIMITED ASBESTOS AND LEAD SURVEY HVAC AND FIRE ALARM UPGRADE PROJECT

John Adams Middle School
2425 16th Street
Santa Monica, CA 90405

Project No.: SMSD-18-7674

Sample Location Drawings: Asbestos and Lead

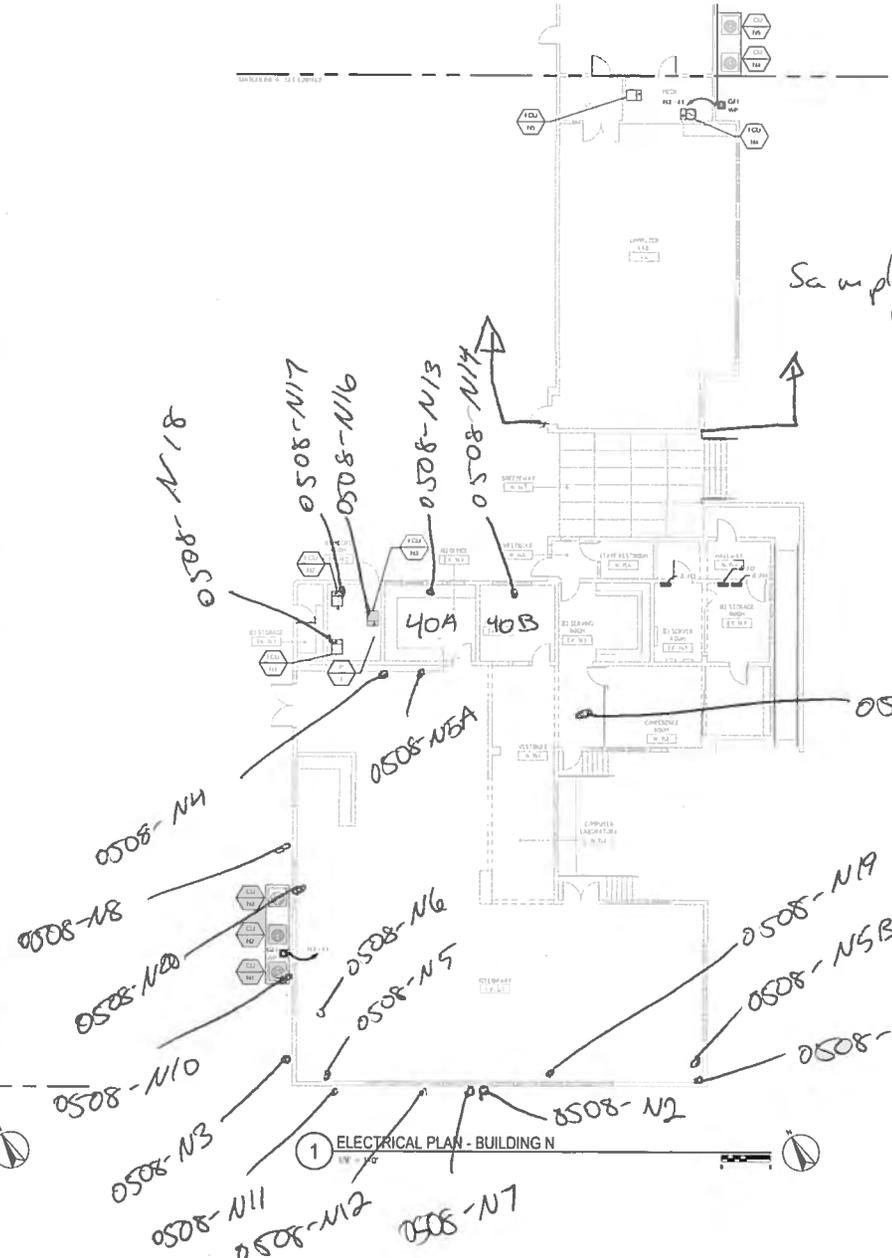
2 ELECTRICAL PLAN - BLDG N & STUDENT COUNCIL
 1/8" = 1'-0"

Sampled with Rldg p

Handwritten annotations on the Building N plan:
 0508-N18
 0508-N17
 0508-N16
 0508-N13
 0508-N14
 0508-N15
 0508-N14
 0508-N15A
 0508-N4
 0508-N8
 0508-N20
 0508-N10
 0508-N3
 0508-N11
 0508-N12
 0508-N7
 0508-N6
 0508-N5
 0508-N2
 0508-N9
 0508-N9B

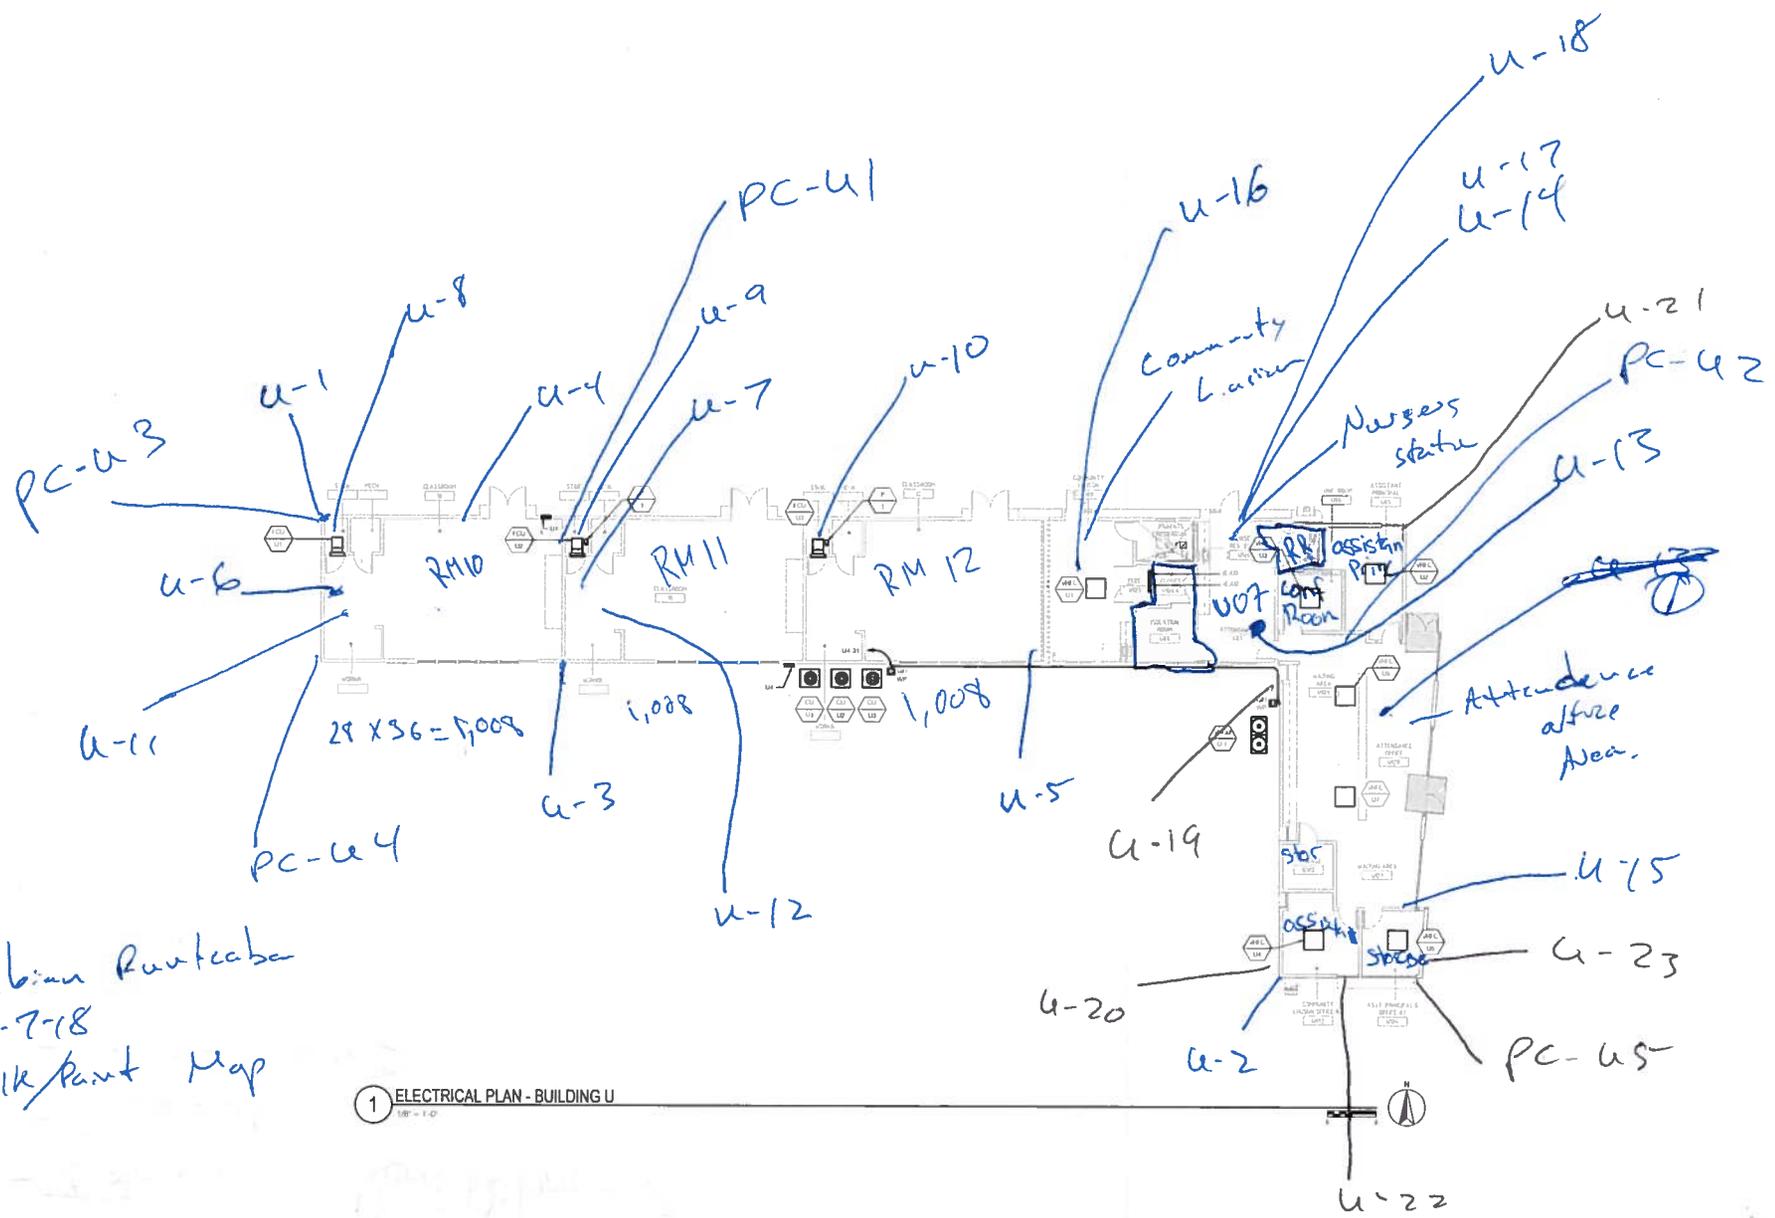
1 ELECTRICAL PLAN - BUILDING U

Fabian Rautava
 5-7-18
 Bulk/Paint Map
